**Flood Control Project Maintenance
Levee Inspections**

2011 Channel Summary Report

Placer County

Truckee River

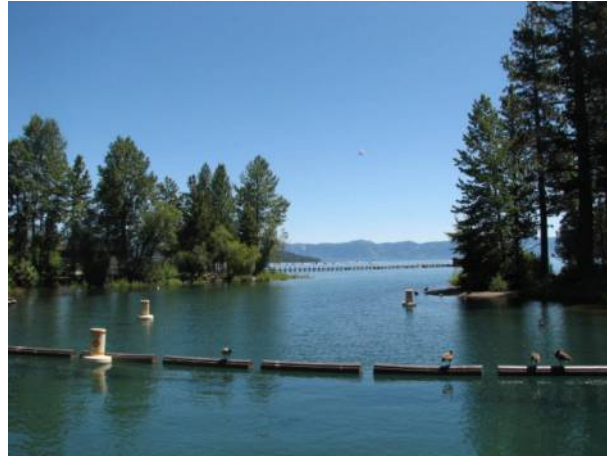
johngw_c_20110725_001.jpg

Levee Mile Report Line	1
Start Levee Mile	0.00
End Levee Mile	0.00
Location	
Category	Channels
Item	Vegetation & Obstructions

The photo was taken from the outlet structure looking towards Lake Tahoe.

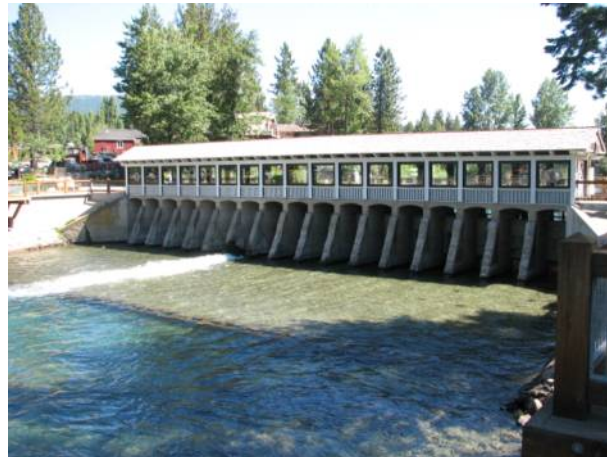
johngw_c_20110725_002.jpg

Levee Mile Report Line	6
Start Levee Mile	0.00
End Levee Mile	0.00
Location	
Category	Channels
Item	Vegetation & Obstructions

The outlet structure at the headwaters of the Truckee River. The out flow has been reduced to 70 CFS.

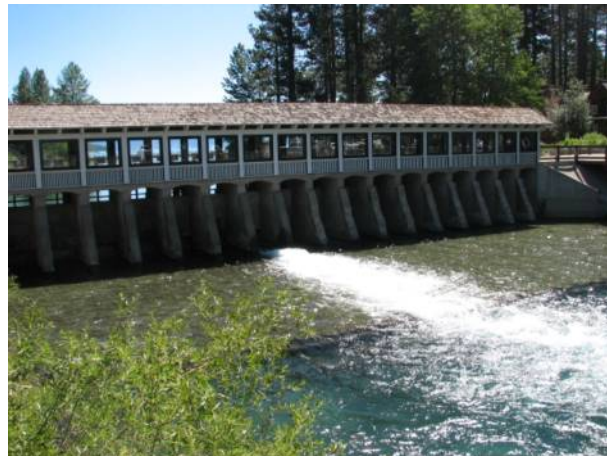
johngw_c_20110725_003.jpg

Levee Mile Report Line	11
Start Levee Mile	0.00
End Levee Mile	0.00
Location	
Category	Channels
Item	Vegetation & Obstructions

The photo is from the Hwy 89 bridge looking upstream.

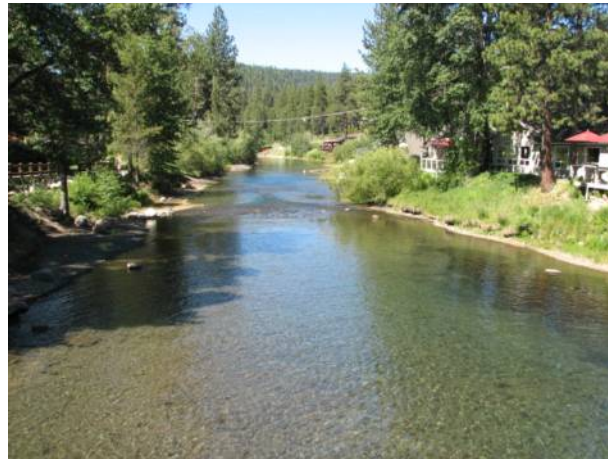
johngw_c_20110725_004.jpg

Levee Mile Report Line	16
Start Levee Mile	0.00
End Levee Mile	0.00
Location	
Category	Channels
Item	Vegetation & Obstructions

The view looking downstream from the Hwy 89 bridge.

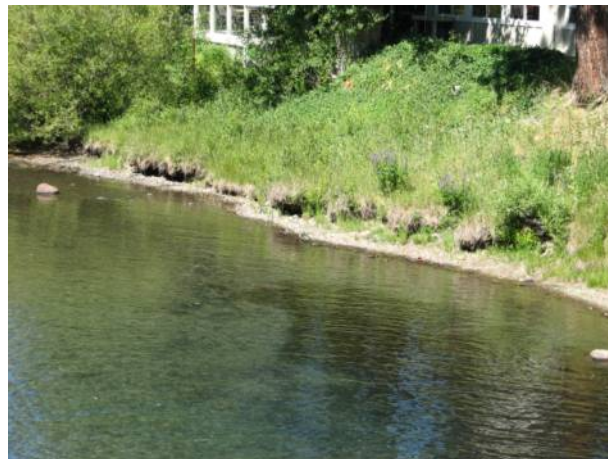
johngw_c_20110725_005.jpg

Levee Mile Report Line	16
Start Levee Mile	0.00
End Levee Mile	0.00
Location	
Category	Channels
Item	Vegetation & Obstructions

With the low flows in the Truckee River you can see the normal flow lines.

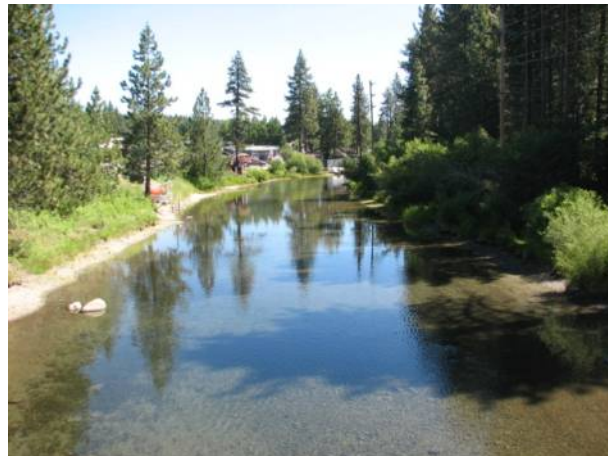
johngw_c_20110725_006.jpg

Levee Mile Report Line	21
Start Levee Mile	0.00
End Levee Mile	0.00
Location	
Category	Channels
Item	Vegetation & Obstructions

The view is looking upstream from the bike bridge.

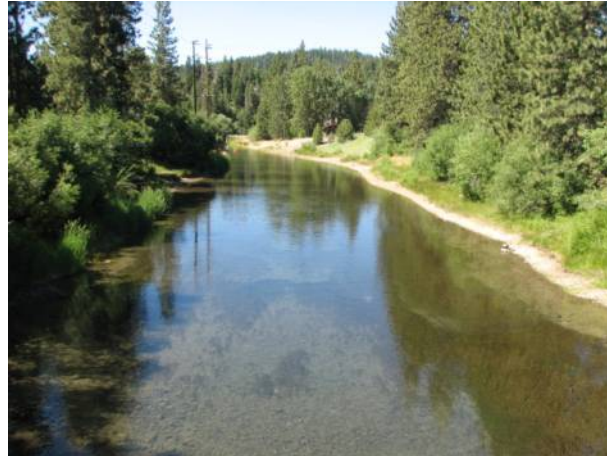
johngw_c_20110725_007.jpg

Levee Mile Report Line	26
Start Levee Mile	0.00
End Levee Mile	0.00
Location	
Category	Channels
Item	Vegetation & Obstructions

Looking downstream from the bike bridge you can see how the low flow.

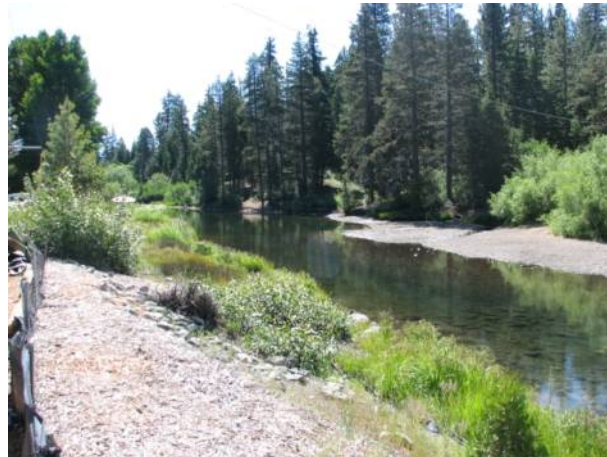
johngw_c_20110725_008.jpg

Levee Mile Report Line	31
Start Levee Mile	0.00
End Levee Mile	0.00
Location	
Category	Channels
Item	Vegetation & Obstructions

The view looking upstream from Tahoe Lumber Yard. You can see the filter cloth and eroison control the lumber yard is using.

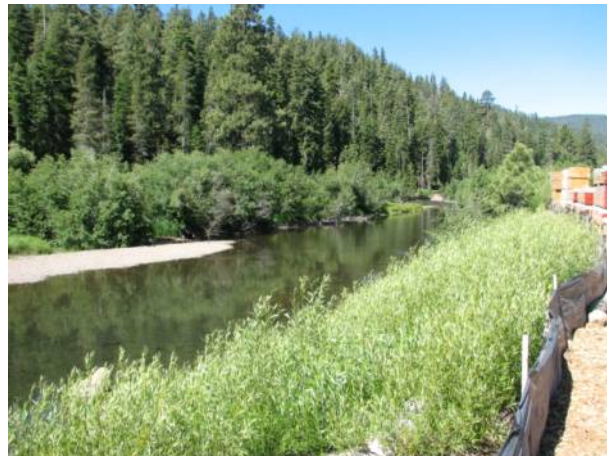
johngw_c_20110725_009.jpg

Levee Mile Report Line	36
Start Levee Mile	0.00
End Levee Mile	0.00
Location	
Category	Channels
Item	Vegetation & Obstructions

The view looking downstream from the Tahoe Lumber Yard.
